**Flood Control Project Maintenance
Levee Inspections**

Maintenance Issue Types Only, Levee Inspection Report By Mile - Fall 2018

Reclamation District No. 2098 Cache and Haas Slough

Waterway	Bank	Unit Miles	Inspection Start/End	Inspector
Unit No. 01 Yolo Bypass	Right	3.60	10/18/2018 10/18/2018	David Julian

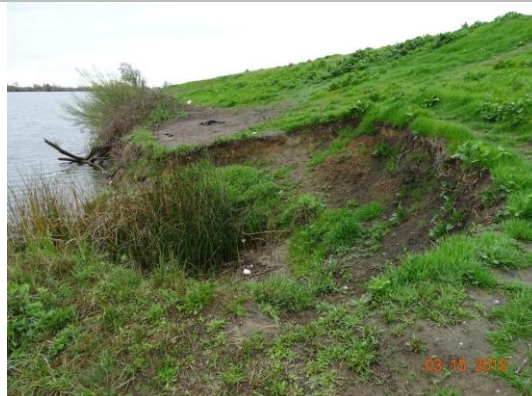
Photo 1 of 1 : FA_2018_RD2098_244_13_20180925_00003.jpg

LM Start	0.57	Rating **	M	Issue No.	13
LM End	1.06	Issue Type +	Ma	Location *	WS
Category	Earthen Levee			GPS Latitude/Longitude	
				Start	End
Item	Erosion / Bank Caving			38.320755 °	38.313700 °
				-121.693982 °	-121.693639 °
DWR ID	DWR_RD2098_01_s_2017_13				
Comment Code					
E2 : Schedule repair of erosion site prior to the next inspection.					
Inspector Comment

Monitor and repair erosion on waterside.

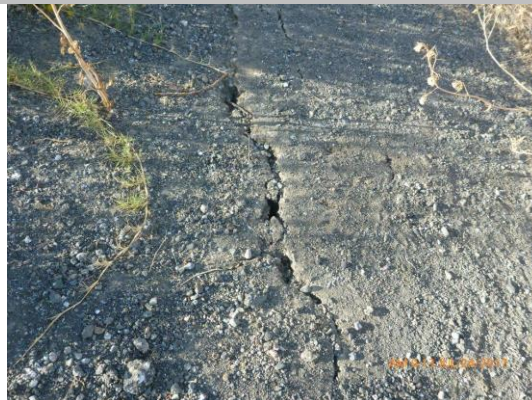
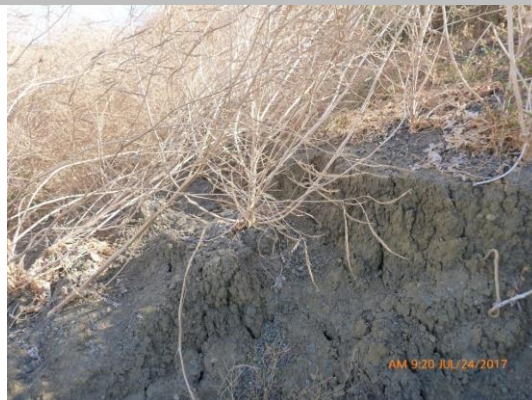
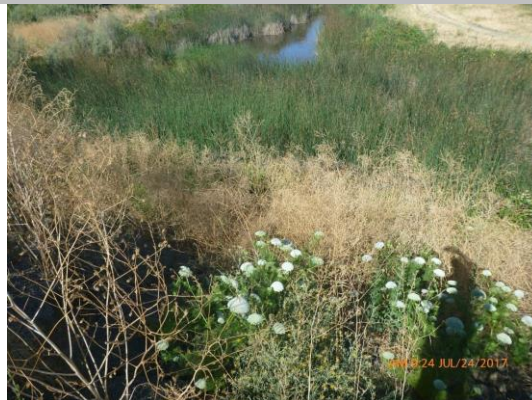
LM Start	0.96	Rating **	A/W	Issue No.	19
LM End	0.96	Issue Type +	Ma	Location *	
Category	Supplemental			GPS Latitude/Longitude	
				Start	End
Item	2017 Storm Damage			38.315200°	38.315100°
				-121.694100°	-121.694100°
DWR ID	DWR_RD2098_01_s_2018_19				
Comment Code					
Inspector Comment					
Levee Evaluation Comments					
Description:The damage consists of cracking and sloughing of the lower landside levee slope.					
Site ID No:414					
Site Designation:LMA-241					
Repair Type: Erosion					
Rating:Area of Concern					
Field Date:7/24/2017					
Notes: Landside sloughing about 2' deep and extends to toe ditch.

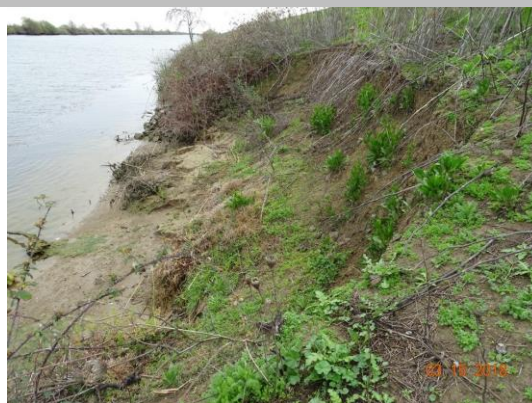
Photo 1 of 1 : FA_2018_RD2098_244_18_20180925_00005.jpg

LM Start	1.76	Rating **	M	Issue No.	18
LM End	1.76	Issue Type +	Ma	Location *	WS
Category	Earthen Levee			GPS Latitude/Longitude	
				Start	End
Item	Erosion / Bank Caving			38.303611 °	38.303611 °
				-121.693607 °	-121.693607 °
DWR ID	DWR_RD2098_01_s_2018_18				
Comment Code					
E2 : Schedule repair of erosion site prior to the next inspection.					
Inspector Comment

Monitor and repair erosion.

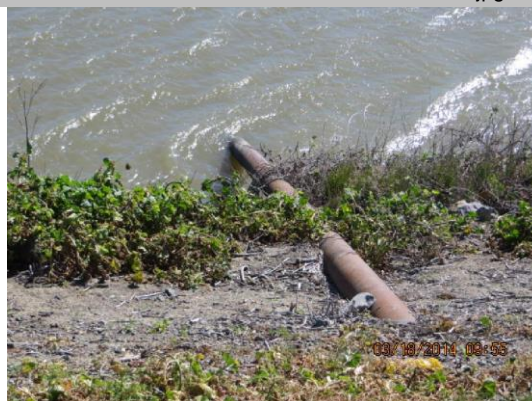
Photo 1 of 3 : UCIP_FA_2018_32197_58662.jpg

Comment Code					
Inspector Comment					
FS_ID:32197 DS_ID:20965 EP_NO: 10168 Repair Type: Non-Urgent Crossing Status: Found UCIP Comments: 12/22/2016 Met with Mike Hadesty, LMA Superintendent, and Brian Bush, LMA General Manager, to go over the list of pipes in RD2098. Per LMA records, this pipe has a different owner. (O. Magana - DWR UCIP) 03/18/2014 Erosion under pipe at WS toe. (W. Wylie - DWR UCIP) FIELD_STRUCT_DESC: 10-inch steel drainage pipe through the levee, 2.8 feet below the crown. Pump in pump house off the landside (LS). (This pipe was retained under Automatic Board Order (ABO) issued as Permit No. 10168, 1974 - Moresco Brothers). [Additional Reference(s): DWR Levee Log, 2003. USACE Sacramento O&M Manual 109, April 1962, (HLM 1.80)]. FS Date: 3/18/2014

Pipe on WS slope.

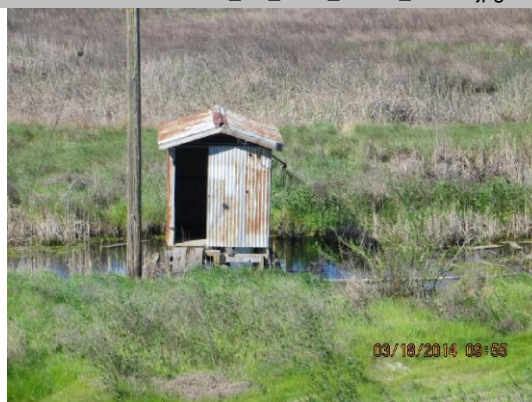
Photo 2 of 3 : UCIP_FA_2018_32197_58661.jpg

Pumphouse at lowpoint off LS toe.

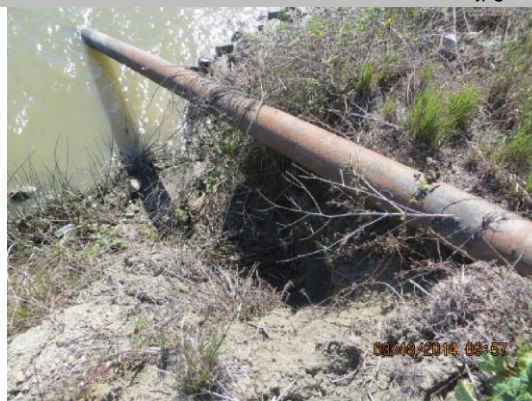
Photo 3 of 3 : UCIP_FA_2018_32197_58660.jpg

Erosion under pipe at WS toe.

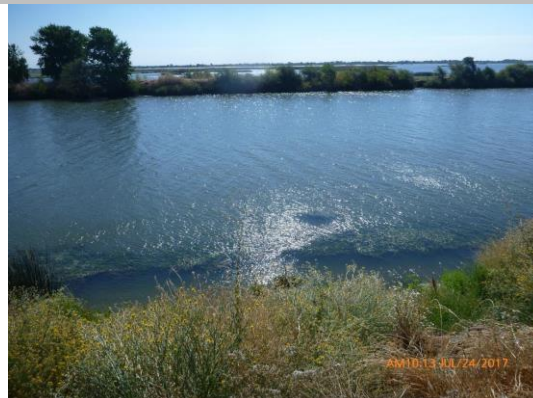
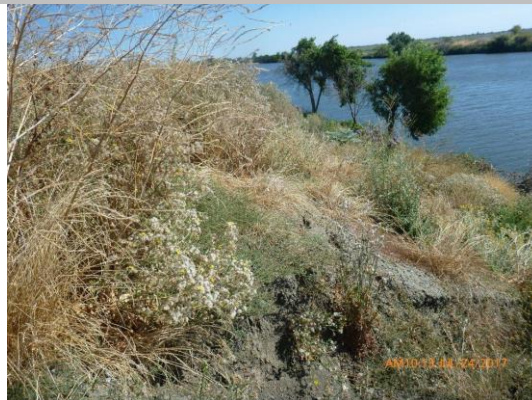
LM Start	2.21	Rating **	A/W	Issue No.	21
LM End	2.22	Issue Type +	Ma	Location *	
Category	Supplemental			GPS Latitude/Longitude	
				Start	End
Item	2017 Storm Damage			38.297100°	38.297000°
				-121.693300°	-121.693300°
DWR ID	DWR_RD2098_01_s_2018_21				
Comment Code					
Inspector Comment					
Levee Evaluation Comments					
Description:The damage consists of erosion, cracking, and sloughing of the waterside levee slope.					
Site ID No:416					
Site Designation:LMA-243					
Repair Type: Erosion					
Rating:Serious					
Field Date:7/24/2017					
Notes: Erosion with sloughing. About 2' vertical cut at top of erosion.

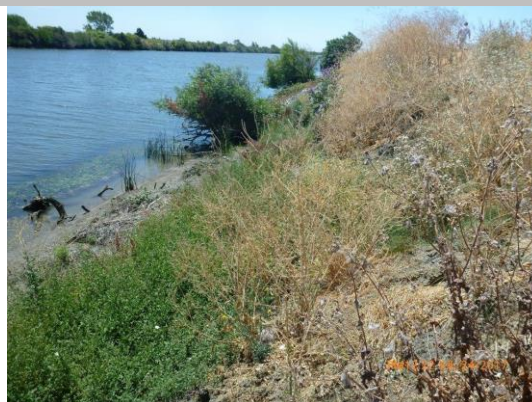
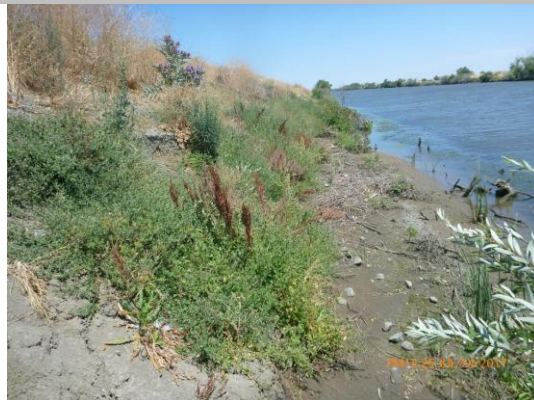
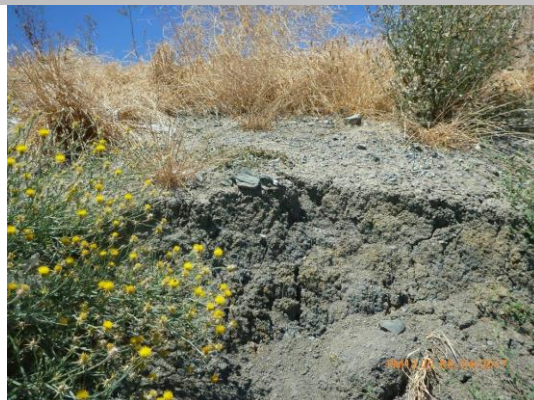
LM Start	2.29	Rating **	A/W	Issue No.	27
LM End	2.31	Issue Type +	Ma	Location *	
Category	Supplemental			GPS Latitude/Longitude	
				Start	End
Item	2017 Storm Damage			38.295900 °	38.295700 °
				-121.693500 °	-121.693500 °
DWR ID	DWR_RD2098_01_f _ 2017_27				
Comment Code					
Inspector Comment					
Levee Evaluation Comments					
Description:The damage consists of scour and sloughing of the waterside levee slope.					
Site ID No:421					
Site Designation:LMA-248					
Repair Type: Erosion					
Rating:Serious					
Field Date:7/24/2017					
Notes: Toe of slope has eroded and minor sloughing has started.

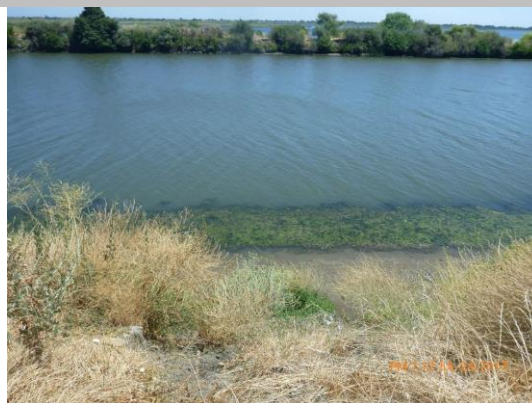
Photo 1 of 3 : FA_2018_RD2098_244_28_20180925_00015.jpg

LM Start	2.35	Rating **	A/W	Issue No.	28
LM End	2.39	Issue Type +	Ma	Location *	
Category	Supplemental			GPS Latitude/Longitude	
				Start	End
Item	2017 Storm Damage			38.295100 °	38.294500 °
				-121.693400 °	-121.693400 °
DWR ID	DWR_RD2098_01_f _ 2017_28				
Comment Code					
Inspector Comment					
Levee Evaluation Comments					
Description:The damage consists of scour, sloughing, and cracking of the lower and mid waterside levee slope.					
Site ID No:423					
Site Designation:LMA-250					
Repair Type: Erosion					
Rating:Area of Concern					
Field Date:7/24/2017					
Notes: 2' of sloughing about half way up the slope.

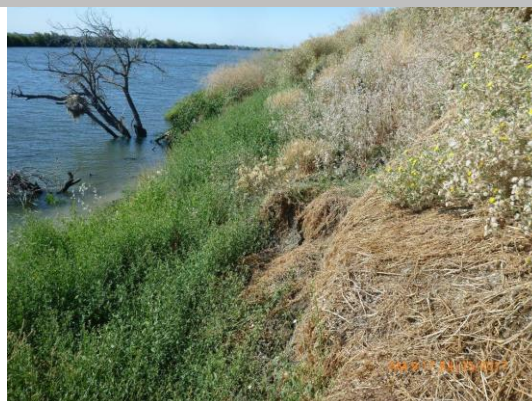
Photo 3 of 3 : FA_2018_RD2098_244_34_20180925_00020.jpg

LM Start	2.75	Rating **	A/W	Issue No.	34 (cont)	
LM End	2.78	Issue Type +	Ma	Location *		
Category	Supplemental			GPS Latitude/Longitude		
				Start		End
Item	2017 Storm Damage			38.289200 °		38.288800 °
				-121.693500 °		-121.693500 °
DWR ID	DWR_RD2098_01_f_2017_34					
Comment Code						
Inspector Comment						
Levee Evaluation Comments						
Description:The damage consists of scour and sloughing of the waterside levee slope.						
Site ID No:429						
Site Designation:LMA-256						
Repair Type: Erosion						
Rating:Serious						
Field Date:7/25/2017						
Notes: Erosion at WS toe, causing sloughing half-way down WS slope.

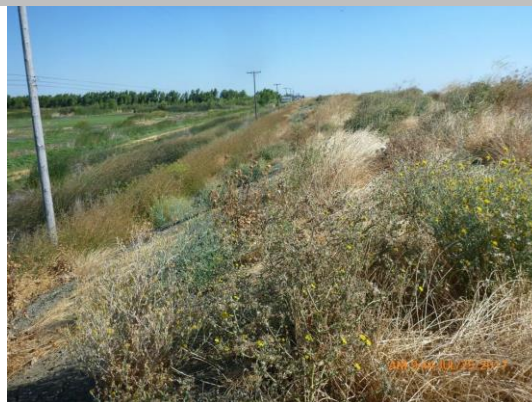
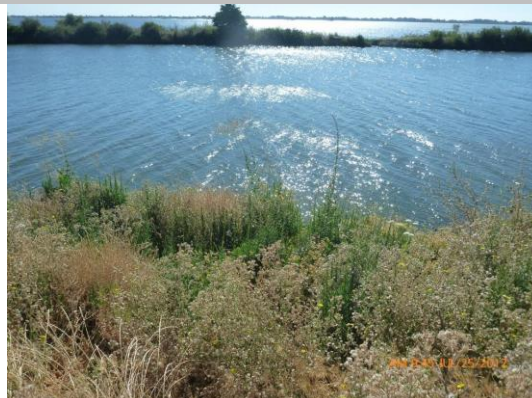
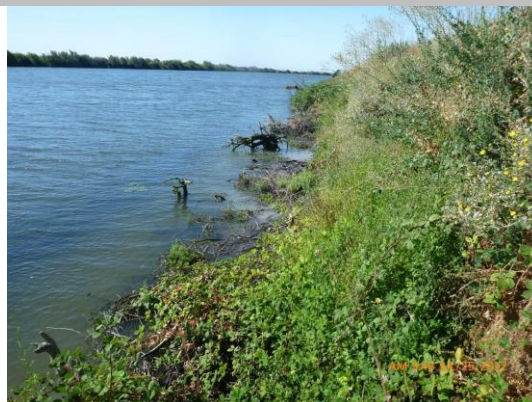
LM Start	2.78	Rating **	A/W	Issue No.	35
LM End	2.81	Issue Type +	Ma	Location *	
Category	Supplemental			GPS Latitude/Longitude	
				Start	End
Item	2017 Storm Damage			38.288800 °	38.288400 °
				-121.693500 °	-121.693500 °
DWR ID	DWR_RD2098_01_f_2017_35				
Comment Code					
Inspector Comment					
Levee Evaluation Comments					
Description:The damage consists of scour and sloughing of the waterside levee slope.					
Site ID No:430					
Site Designation:LMA-257					
Repair Type: Erosion					
Rating:Serious					
Field Date:7/25/2017					
Notes: Erosion at waterside toe, causing sloughing 2/3 down waterside slope.

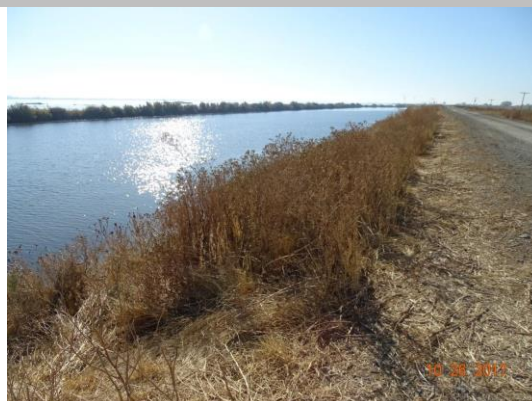
Photo 1 of 1 : FA_2018_RD2098_244_11_20180925_00001.jpg

Nearby construction operations forced termination of goat grazing.
Vegetation should be cleared.

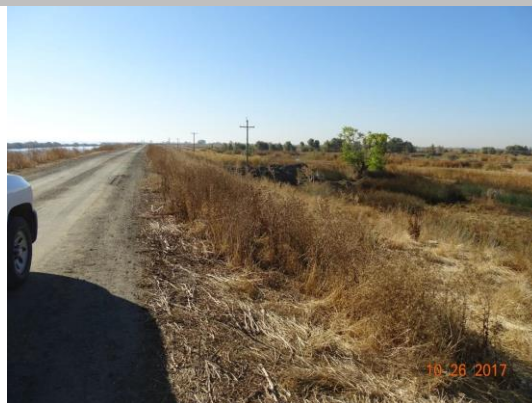
Photo 1 of 1 : FA_2018_RD2098_244_12_20180925_00002.jpg

Nearby construction operations forced termination of goat grazing.
Vegetation should be cleared.

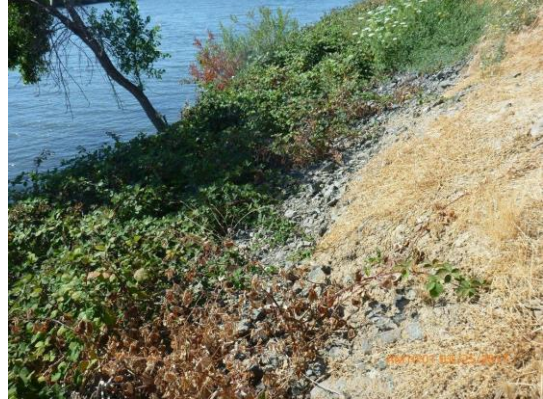
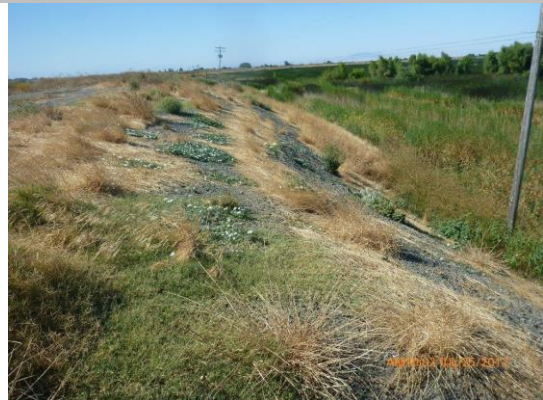
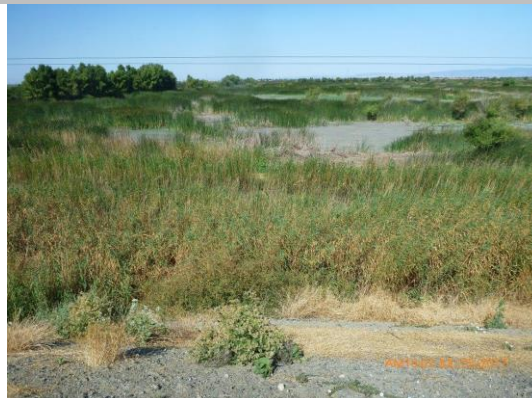
LM Start	2.91	Rating **	A/W	Issue No.	36	
LM End	2.93	Issue Type +	Ma	Location *		
Category	Supplemental			GPS Latitude/Longitude		
				Start	End	
Item	2017 Storm Damage			38.286900 °	38.286700 °	
				-121.693500 °	-121.693500 °	
DWR ID	DWR_RD2098_01_f_2017_36					
Comment Code						
Inspector Comment						
Levee Evaluation Comments						
Description:The damage consists of scour and sloughing of the waterside levee slope.						
Site ID No:431						
Site Designation:LMA-258						
Repair Type: Erosion						
Rating:Serious						
Field Date:7/25/2017						
Notes: Erosion of WS toe, resulting in 8' verticle wall.

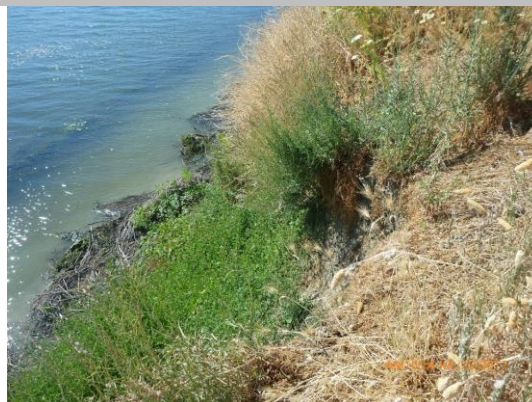
Photo 1 of 3 : FA_2018_RD2098_244_37_20180925_00027.jpg

LM Start	2.99	Rating **	A/W	Issue No.	37
LM End	3.29	Issue Type +	Ma	Location *	
Category	Supplemental			GPS Latitude/Longitude	
				Start	End
Item	2017 Storm Damage			38.285700°	38.281500°
				-121.693500°	-121.694300°
DWR ID	DWR_RD2098_01_f_2017_37				
Comment Code					
Inspector Comment					
Levee Evaluation Comments					
Description:The damage consists of scour and sloughing of the waterside levee slope.					
Site ID No:432					
Site Designation:LMA-259					
Repair Type: Erosion					
Rating:Serious					
Field Date:7/25/2017					
Notes: Varying erosion and sloughing at WS toe. Revetment at end of levee section.

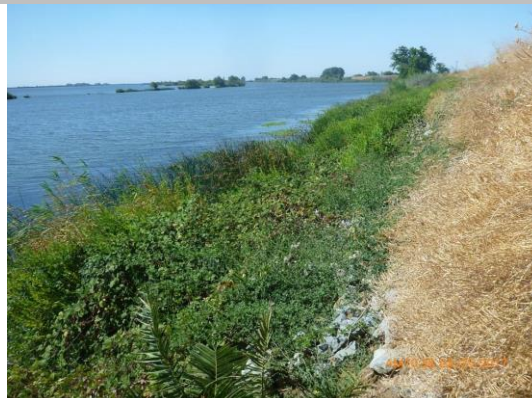
Photo 3 of 3 : FA_2018_RD2098_244_39_20180925_00035.jpg

LM Start	3.31	Rating **	A/W	Issue No.	39 (cont)
LM End	3.32	Issue Type +	Ma	Location *	
Category	Supplemental			GPS Latitude/Longitude	
				Start	End
Item	2017 Storm Damage			38.281200°	38.281100°
				-121.694500°	-121.694600°
DWR ID	DWR_RD2098_01_f_2017_39				
Comment Code					
Inspector Comment					
Levee Evaluation Comments Description: The damage consists of scour and sloughing of the lower waterside levee slope. Site ID No: 433 Site Designation: LMA-260 Repair Type: Erosion Rating: Area of Concern Field Date: 7/25/2017 Notes: Two combined erosion sites (260 and 261) adjacent to each other at WS toe. Existing rip rap placed at area of concern.

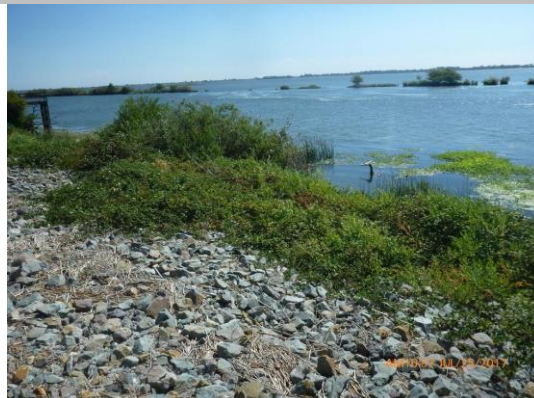
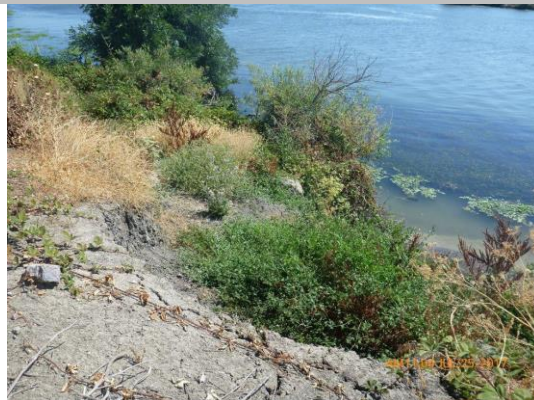
LM Start	3.50	Rating **	M	Issue No.	40
LM End	3.56	Issue Type +	Ma	Location *	
Category	Supplemental			GPS Latitude/Longitude	
				Start	End
Item	2017 Storm Damage			38.278700 °	38.278000 °
				-121.695900 °	-121.696100 °
DWR ID	DWR_RD2098_01_f_2017_40				
Comment Code					
Inspector Comment					
Levee Evaluation Comments					
Description:The damage consists of scour and sloughing of the lower and mid waterside levee slope.					
Site ID No:435					
Site Designation:LMA-262					
Repair Type: Erosion					
Rating:Area of Concern					
Field Date:7/25/2017					
Notes: Two combined sloughing sites adjacent to each other on lower waterside slope. Existing rip rap on beginning 100' section of site 262.					
This site is combined with site 263.

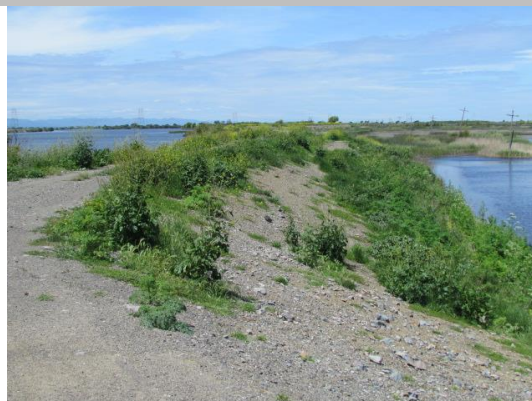
Photo 1 of 1 : FA_2018_RD2098_246_8_20180925_00001.jpg

RD 2098 Unit 2 Levee mile 5.30-7.14 wild growth on the landside slope.

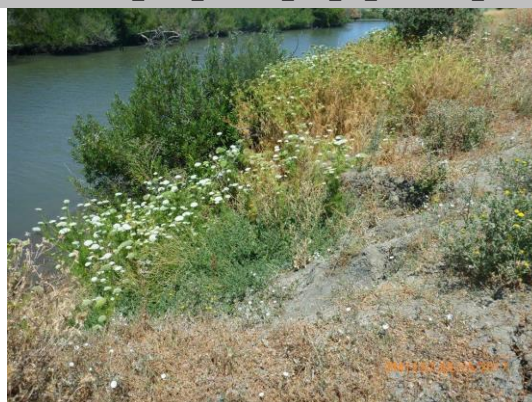
Photo 1 of 3 : FA_2018_RD2098_246_17_20180925_00008.jpg

LM Start	6.47	Rating **	A/W	Issue No.	17
LM End	6.48	Issue Type +	Ma	Location *	
Category	Supplemental			GPS Latitude/Longitude	
				Start	End
Item	2017 Storm Damage			38.288900 °	38.289000 °
				-121.717000 °	-121.717000 °
DWR ID	DWR_RD2098_02_f _ 2017_17				
Comment Code					
Inspector Comment					
Levee Evaluation Comments					
Description:The damage consists of scour and sloughing of the lower and mid waterside levee slope.					
Site ID No:441					
Site Designation:LMA-268					
Repair Type: Erosion					
Rating:Area of Concern					
Field Date:7/25/2017					
Notes: Sloughing on waterside slope due to toe erosion.

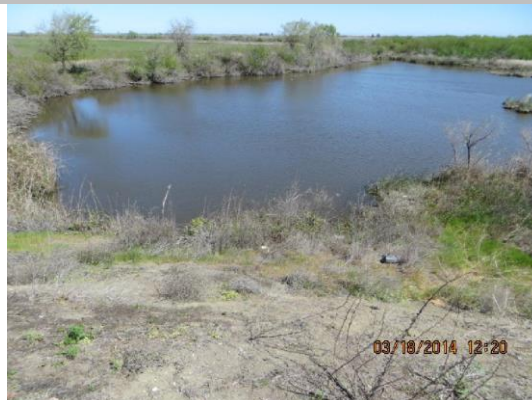
Photo 2 of 3 : UCIP_FA_2018_33784_61161.jpg

Inlet not visible on LS toe.

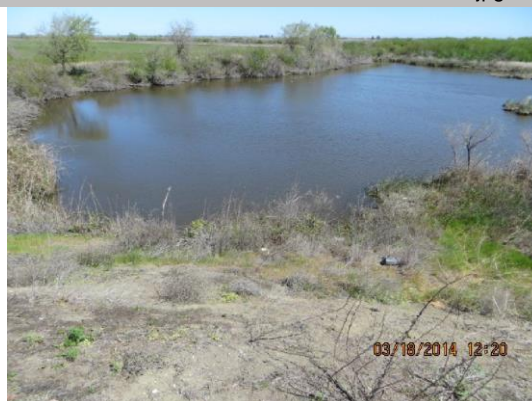
Photo 1 of 3 : UCIP_FA_2018_32285_58749.jpg

Inlet not visible on LS toe.

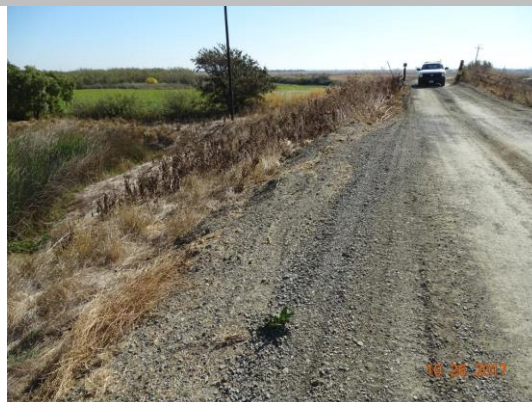
Photo 4 of 4 : FA_2018_RD2098_246_20_20180925_00020.jpg

10/26/17: Notice depression in crown road and slumping toward the left/landside (bulge at toe of levee).

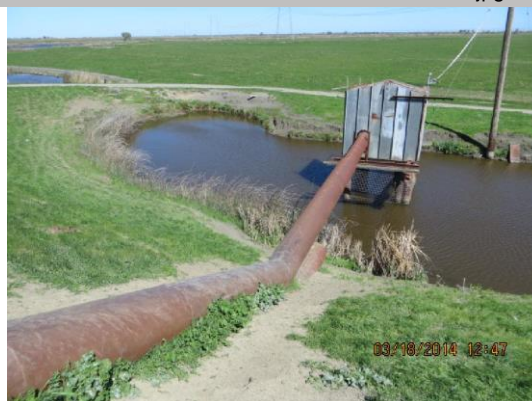
Photo 1 of 3 : UCIP_FA_2018_32303_58782.jpg

Pipe visible under new pipe on LS slope.

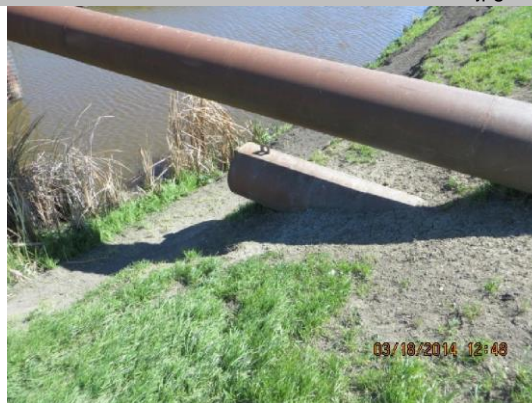
Photo 2 of 3 : UCIP_FA_2018_32303_58781.jpg

Pipe visible under new pipe on LS slope.

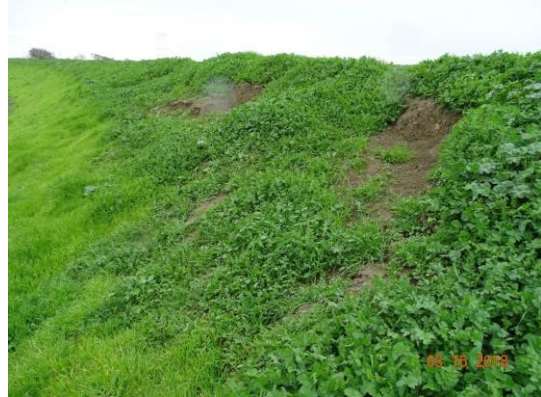
Photo 2 of 3 : FA_2018_RD2098_247_1_20180925_00002.jpg

Erosion site on 03/15/18.

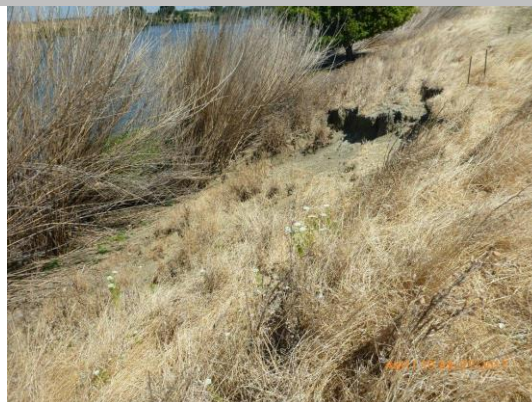
Photo 1 of 3 : FA_2018_RD2098_247_13_20180925_00011.jpg

LM Start	7.63	Rating **	M	Issue No.	13
LM End	7.64	Issue Type +	Ma	Location *	
Category	Supplemental			GPS Latitude/Longitude	
				Start	End
Item	2017 Storm Damage			38.298300 °	38.298400 °
				-121.728800 °	-121.728800 °
DWR ID	DWR_RD2098_03_f _ 2017_13				
Comment Code					
Inspector Comment					
Levee Evaluation Comments					
Description:The damage consists of scour and sloughing of the waterside levee slope.					
Site ID No:450					
Site Designation:LMA-277					
Repair Type: Erosion					
Rating:Area of Concern					
Field Date:7/27/2017					
Notes: Sloughing on waterside due to waterside toe erosion.

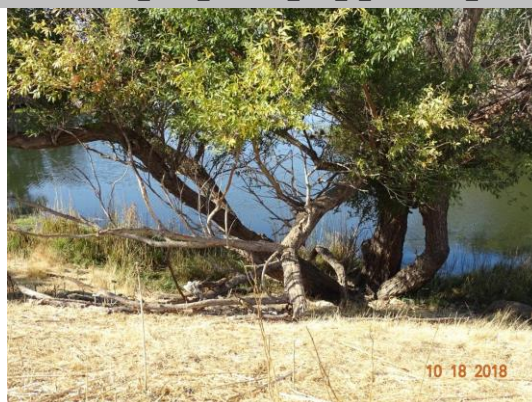
LM Start	7.87	Rating **	M	Issue No.	9	
LM End	7.87	Issue Type +	Ma	Location *	WS	
Category	Earthen Levee			GPS Latitude/Longitude		
				Start	End	
Item	Encroachments			38.301707 °	38.301707 °	
				-121.728045 °	-121.728045 °	
DWR ID	DWR_RD2098_03_s_2014_9					
Comment Code						
TR : Tree or limb						
Inspector Comment						
Remove the fallen tree limb from the water side slope.

View of fallen tree limb on the water side slope (October 2018).

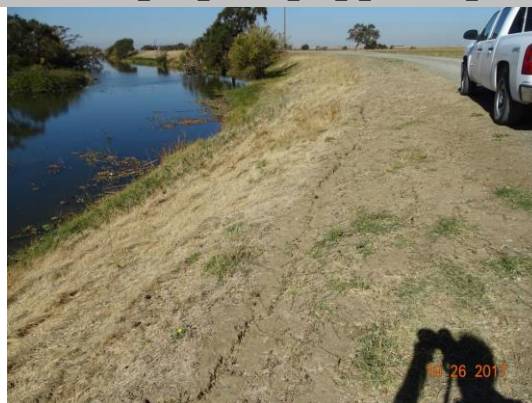
View upstream of cracks in waterside shoulder.
